Test Intention:

In test 4345 we want to investigate the lifespan of CFROBOT8.060 for torsion applications with a motion of $\pm 180^\circ$.

Series / No: CFROBOT8.060

Installation type: Torsion, $\pm 180^\circ$

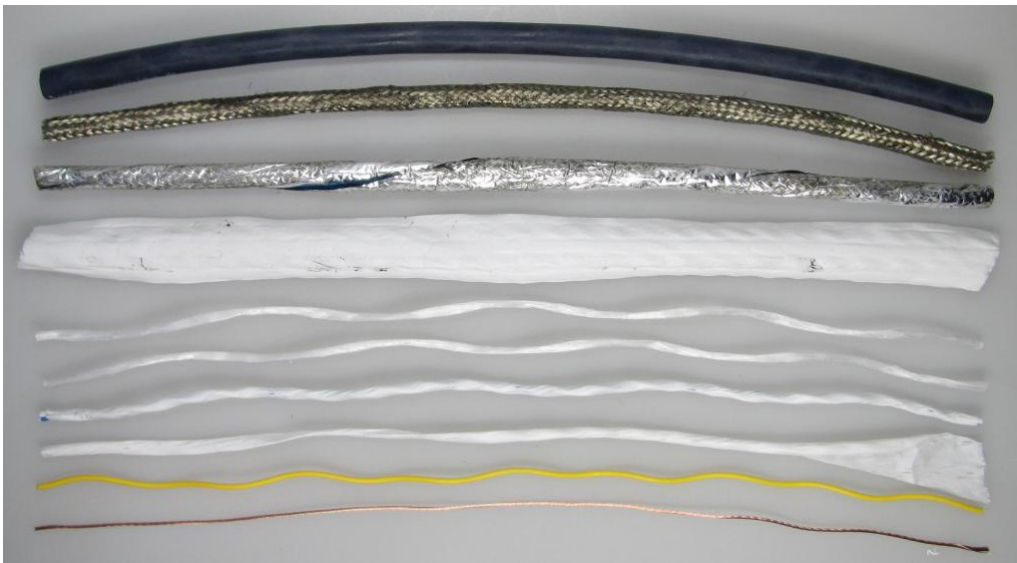
At the 02.10.2012 after 5.757.723 ds, we demounted cable no. 1.1, because FLUKE notifies fail on the shielding.

The condition of the cable no.1.1 (CFROBOT8.060) after 5.757.723 cycles

The ruptured tinned braided copper shield

Overview of the dissected piece of the cable no.1.1, CFROBOT8.060.

Cycles [$\pm 180^\circ$]	5.757.723
Condition outer jacket	o.k.
Condition overall shielding	ruptured
Condition outer banding	ruptured
Condition inner banding	o.k.
Condition filler	o.k.
Condition element banding	o.k.
Condition core insulation	o.k.
Condition core stranding	o.k.

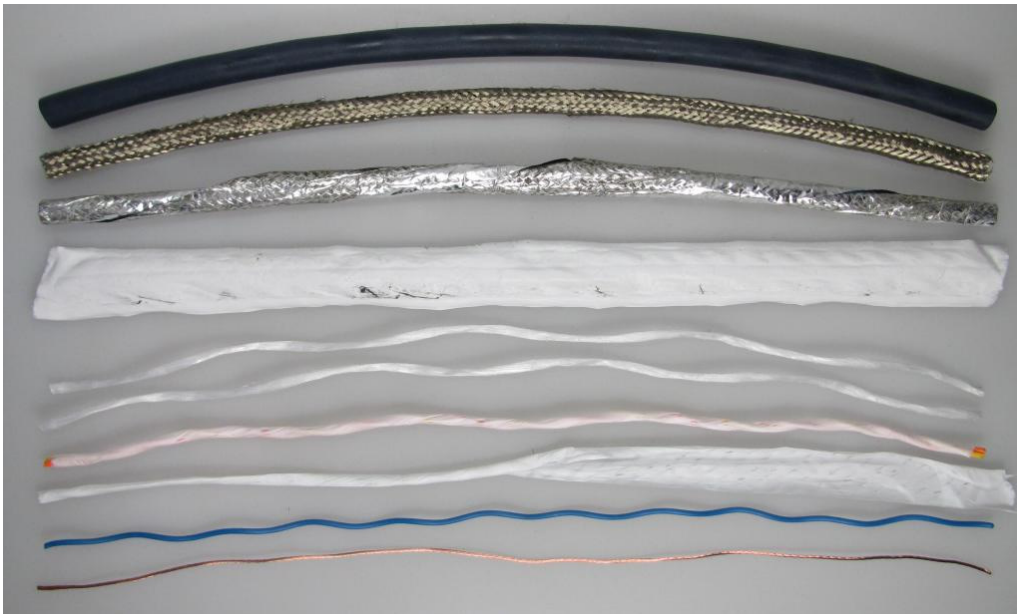
At the 20.09.2012 after 5.520.483 ds, we demounted cable no. 1.2, because FLUKE notifies fail on the shielding.

The condition of the cable no.1.2 (CFROBOT8.060) after 5.520.483 cycles

The ruptured tinned braided copper shield

Overview of the dissected piece of the cable no.1.2, CFROBOT8.060.

Cycles [$\pm 180^\circ$]	5.520.483
Condition outer jacket	o.k.
Condition overall shielding	ruptured
Condition outer banding	ruptured
Condition inner banding	o.k.
Condition filler	o.k.
Condition element banding	o.k.
Condition core insulation	o.k.
Condition core stranding	o.k.
